TEST REPORT #208125

SSBP-20 AND SSBP-16
MICROWAVE COAXIAL ASSEMBLIES
TESTED FOR USE IN STANDARD MULTI-CONTACT
MIL-DTL-38999 CONNECTORS

SOUTHWEST MICROWAVE, INC.

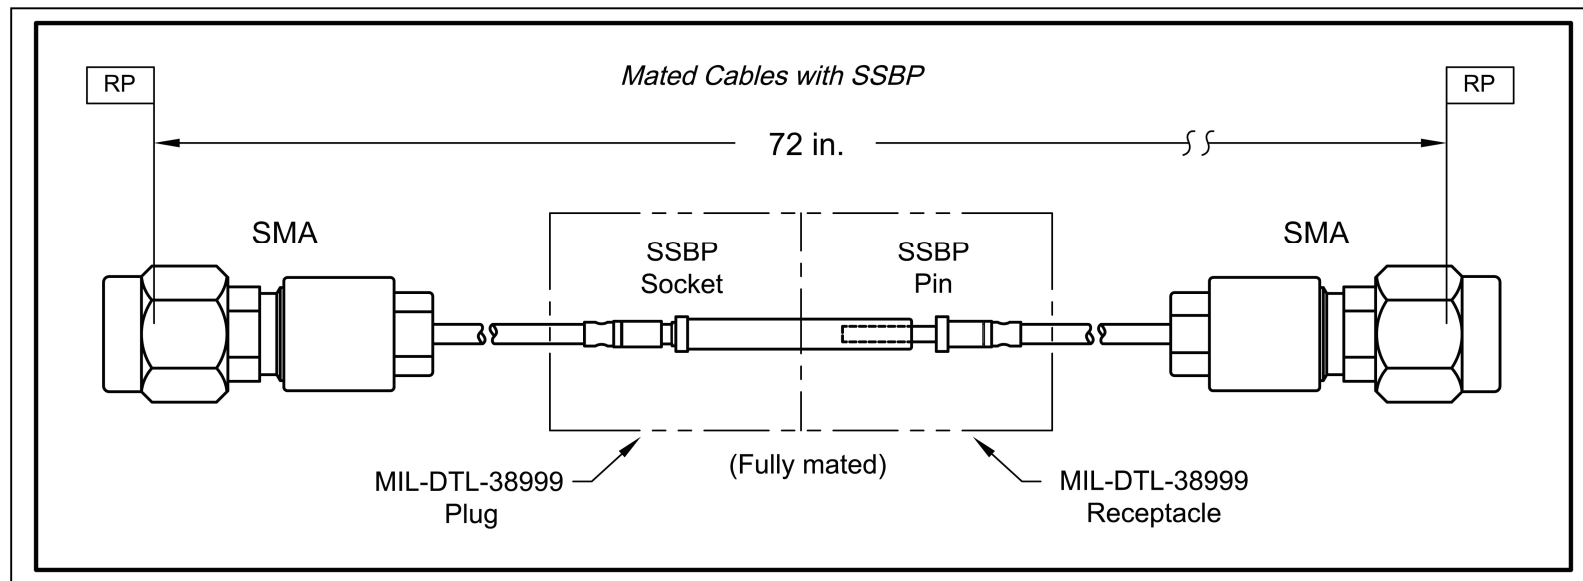
Schematic of Single-Line SSBP-to-SSBP within mated D38999 "host" connectors. VSWR measurements include RP to RP (SMA/plugs, cables, and SSBP P/S pair).

1. Testing focuses on coaxial assemblies, results of VSWR measurements are deemed critical to confirm performance.
2. VSWR measurements were taken multiple times during the testing. Signal continuity was maintained at 6 GHz during vibration.
3. All VSWR measurements were at 6 GHz. test configuration is in accordance with Figure 2.

1. The test was performed in accordance with Specification EIA-364, Test procedure 108. Basic interconnect schematic is shown in Figure 2 (page 8).
2. The test equipment including cables and adapters was calibrated using precision 0 and 50 ohm loads and high frequency test leads.
3. The test samples under test were terminated using SMA terminations which connected to test system and the characteristic VSWR was measured.
4. The VSWR was plotted over the range of frequencies listed with discreet points measured as noted below.
5. Test Conditions:
 - a) Frequency Range : 3.0 MHz thru 6.0 GHz
 - b) Termination Impedance : 50 Ω
 - c) No. of Positions Tested : 3 positions

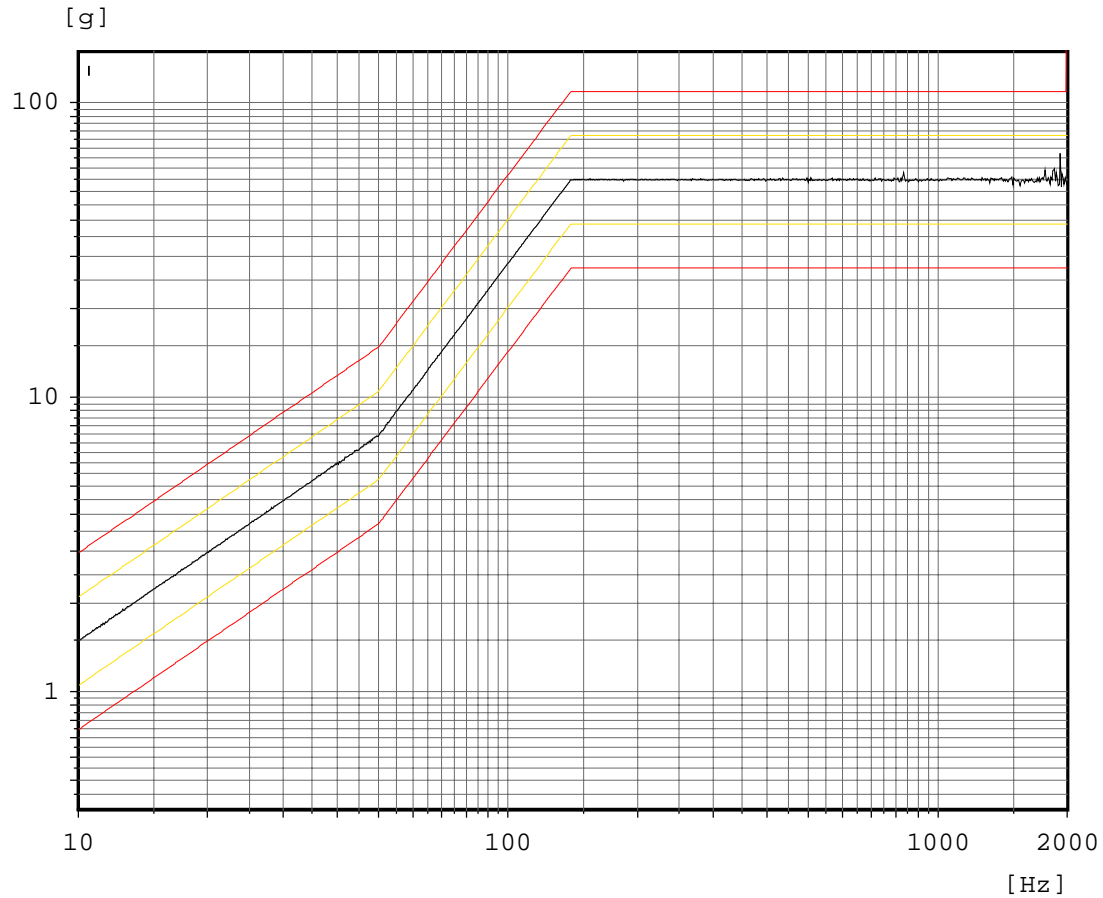
FIGURE #3

Project# 208125
Run 60G
Z-Axis
Test Conditions:
10-2000-10Hz
ID#:9P10R,1P2R
Tech:MOB
Date:07/09/09

1. The test samples as tested met the requirements as specified.
2. There was no physical damage to the test samples as tested.
3. There was no interruption greater than 1.0 microsecond.
4. The sinusoidal vibration profiles are illustrated in the Figures #3, #4 and #5.
5. The sinusoidal vibration photos are illustrated in the Figures #6, #7 and #8.

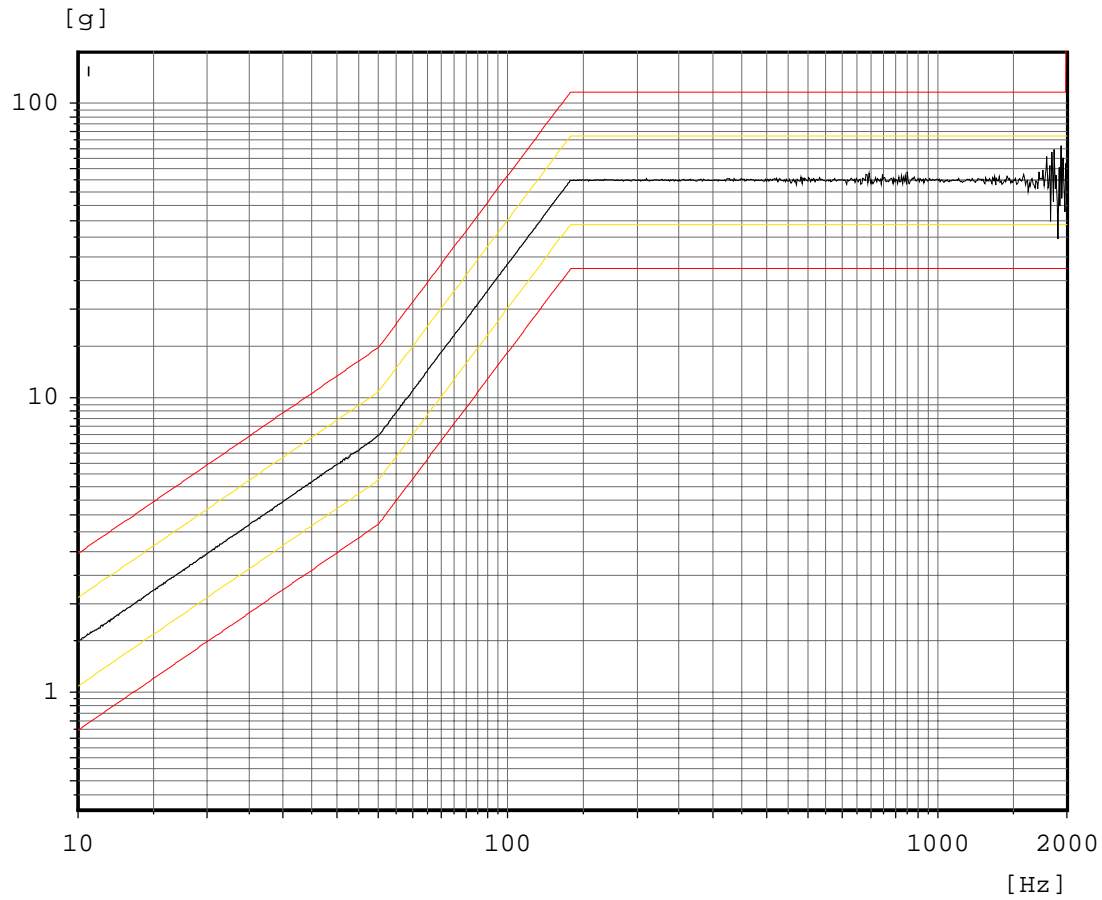
FIGURE #4

Project# 208125
Run 60G Sine
X-Axis
Test Conditions:
10 to 2000 to 10 Hz
60G
ID#:9P10R,1P2R
Tech:MOB
Date:07/13/09

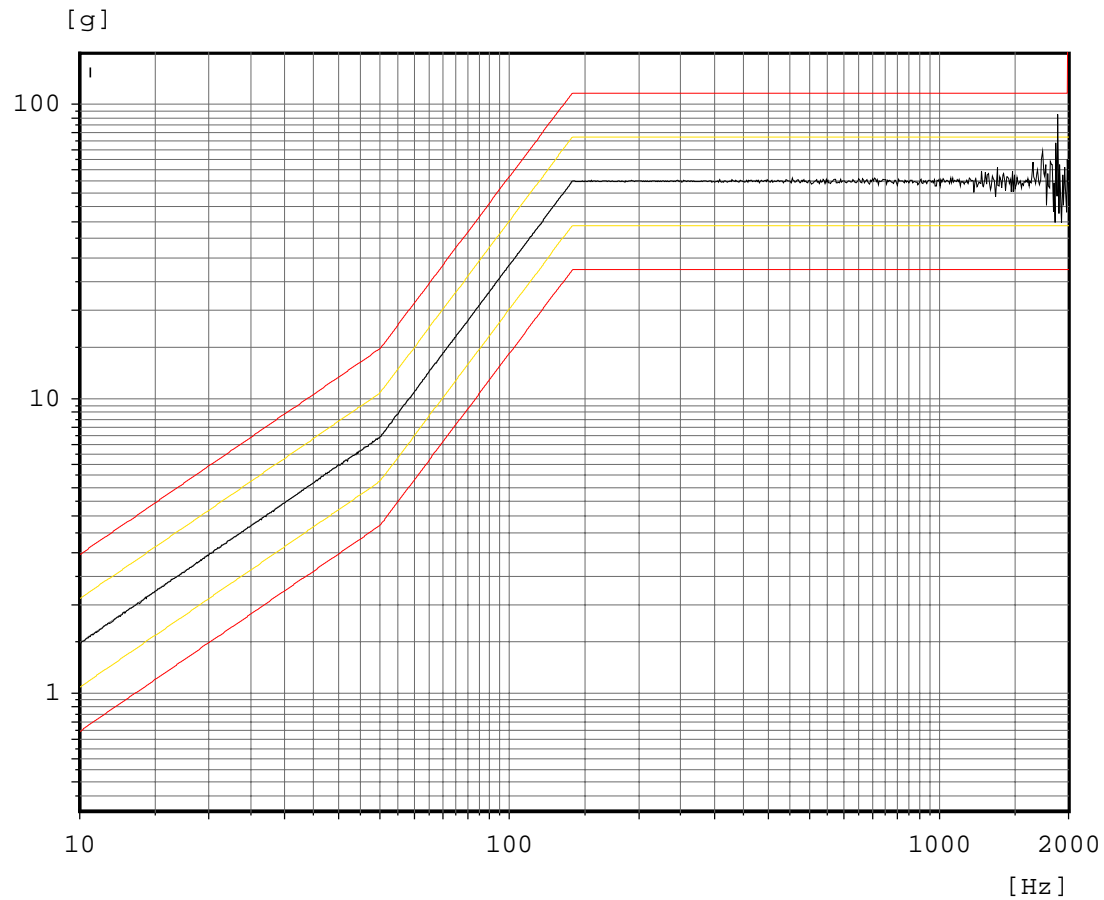
FIGURE #5

Project# 208125
Run60G
Y-Axis
Test Conditions:
10-2000-10Hz, 60G
ID#: 9P10R, 1P2R
Tech: MOB
Date: 07/15/09

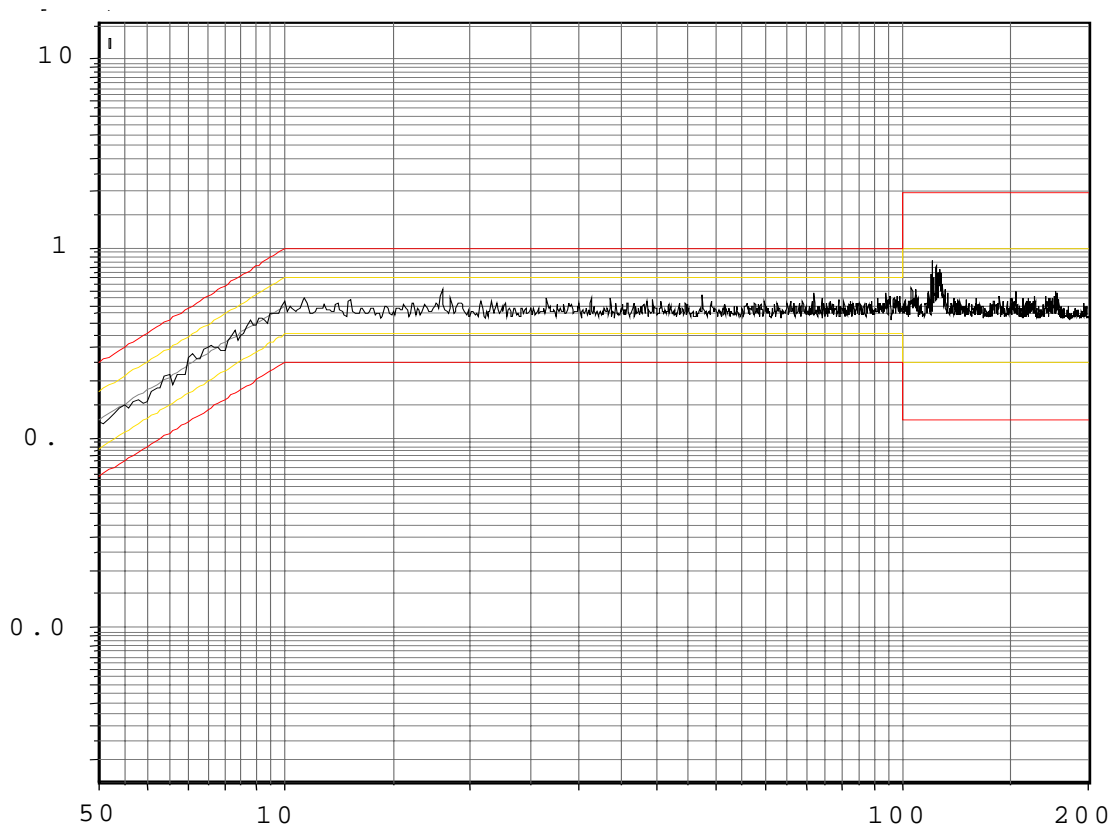
FIGURE #9

Project# 208125
Run 43.9G
Longitudinal-Axis
Test Conditions:
50Hz to 2000Hz
43.9G Random
ID#:11P12R,3P4R
Tech: MOB
Date:07/17/09

1. The test samples as tested met the requirements as specified.
2. There was no physical damage to the test samples as tested.
3. There was no interruption greater than 1.0 microsecond.
4. The random vibration profiles are illustrated in Figures #9 and #10.
5. The random vibration photos are illustrated in Figures #11 and #12.

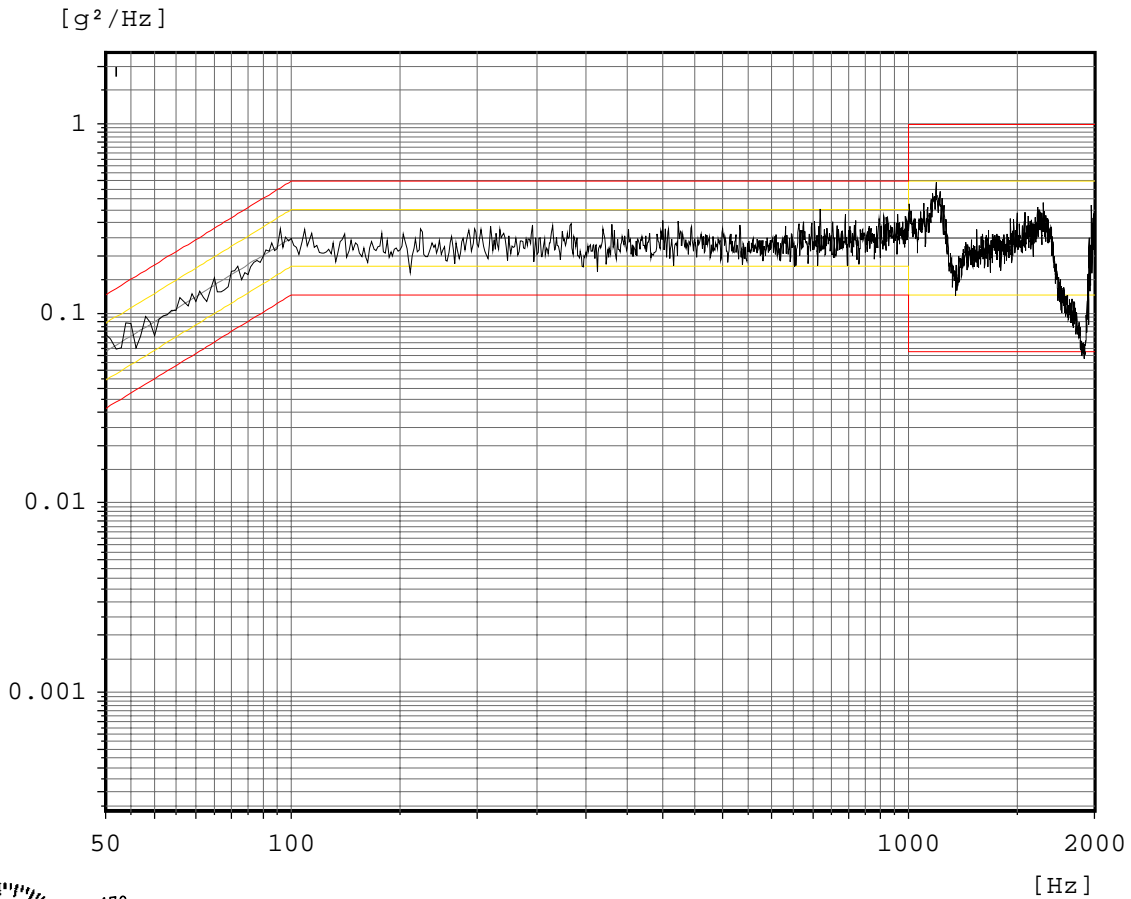
FIGURE #10

Project# 208125
Run 43.9G
Perpendicular -Axis
Test Conditions:
43.9G Random
50Hz to 2000Hz
ID#:11p12R,3P4R
Tech:MOB
Date:07/20/09

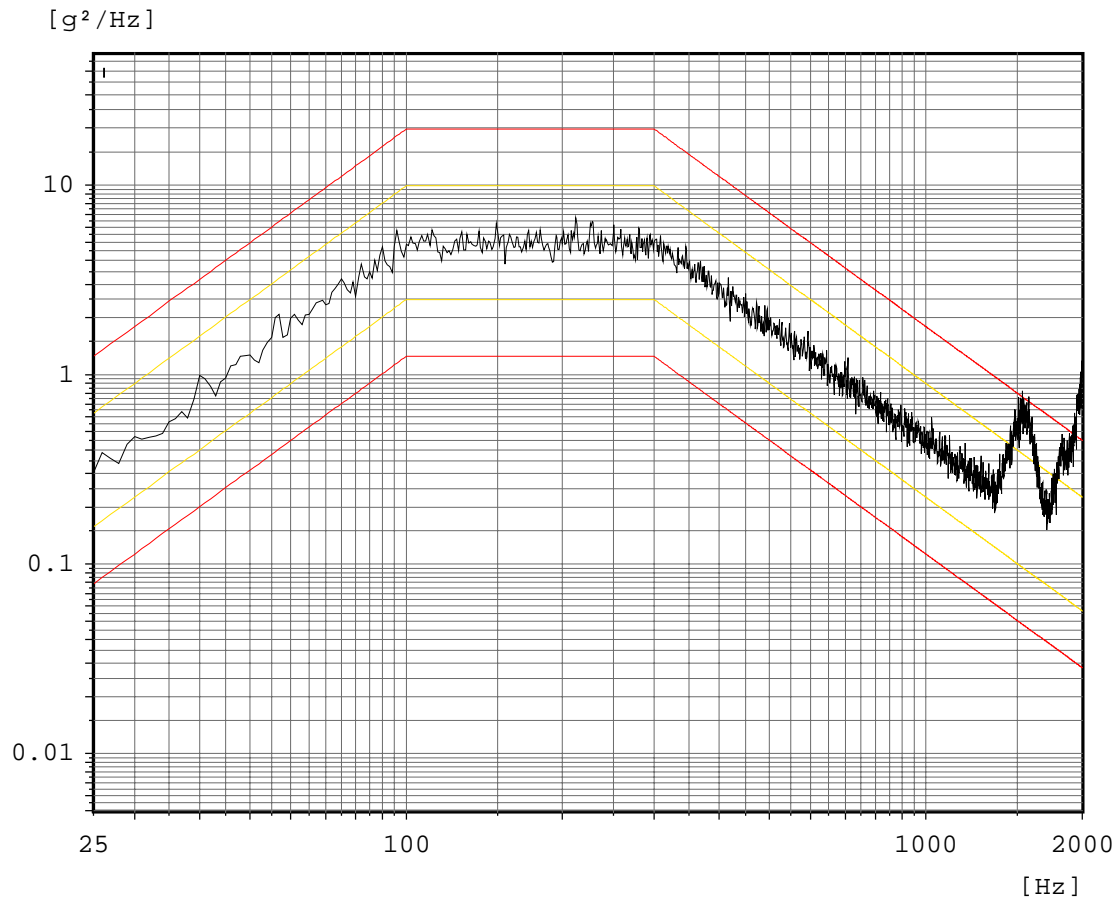
FIGURE #13
Control channel

Project# 208125
Run 50G
Longitudinal -Axis
Test Conditions:
25 Hz to 2000 Hz
50G Random
ID#: 13P14R,5P6R
Tech:MOB
Date:08/02/09

1. The test samples as tested met the requirements as specified.
2. There was no physical damage to the test samples as tested.
3. There was no interruption greater than 1.0 microsecond.
4. The random vibration profiles are illustrated in Figures #13 and #14.
5. The random vibration photos are illustrated in Figures #15 and #16.

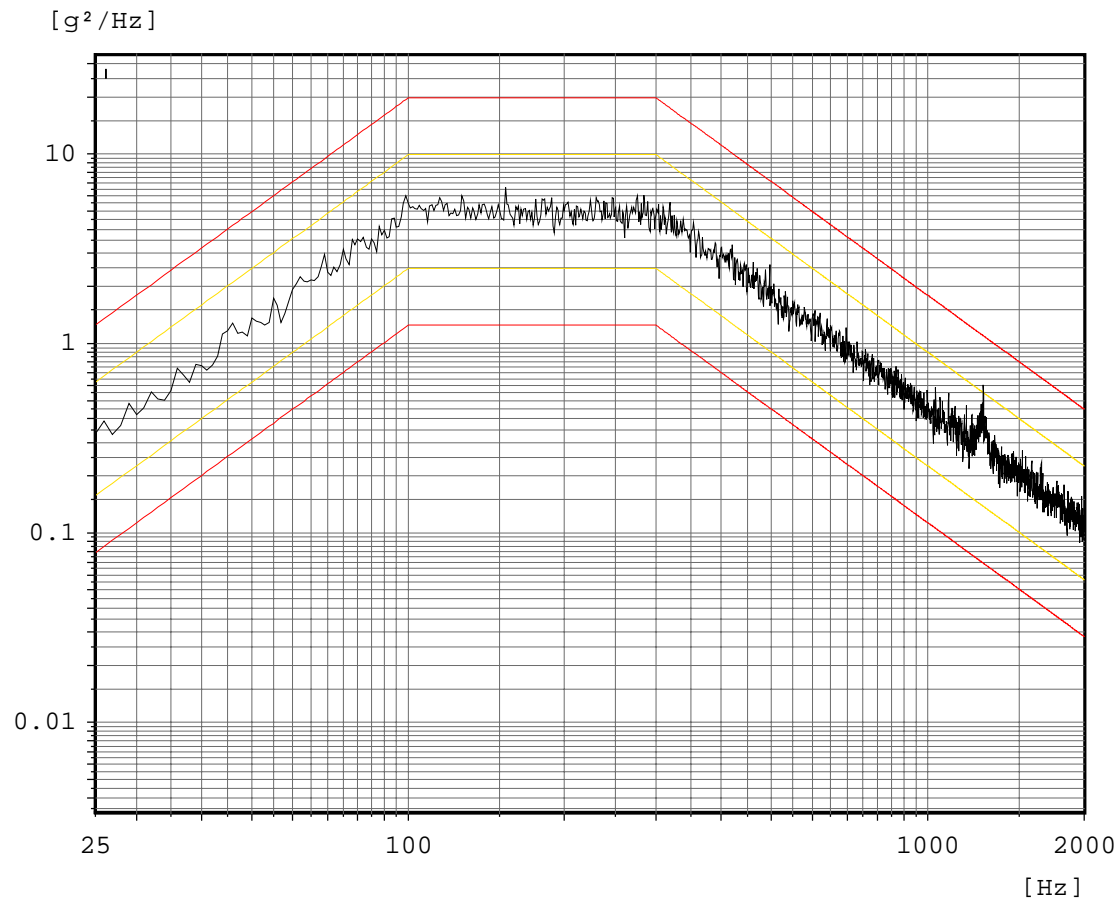
FIGURE #14

Project# 208125
Run:50G
Perpendicular -Axis
Test Conditions:
25Hz to 2000Hz
50G Random
ID#:13P14R,5P6R
Tech: MOB
Date:08/07/09

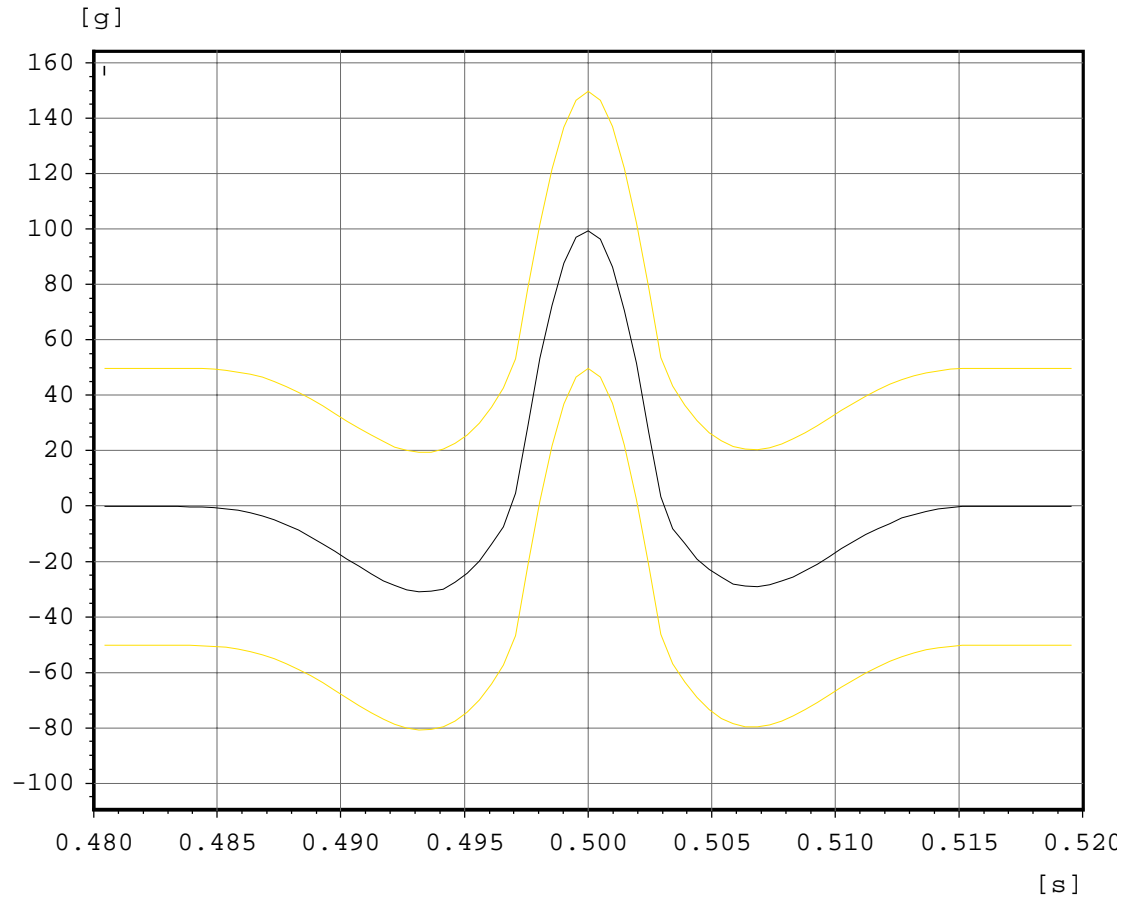
FIGURE #17

Project 208125
Cal Wave 1
Southwest
Microwave
Tech: /MOB
07/27/09

1. The test samples as tested met the requirements as specified.
2. There was no evidence of physical damage to the test samples as tested.
3. There was no contact interruption greater than 1.0 microsecond.
4. The Mechanical Shock characteristics are shown in Figures #17 and #18 (Calibration Pulse) and #19 (Test Pulse). Each figure displays the shock pulse contained within the upper and lower limits as defined by the appropriate test specification.

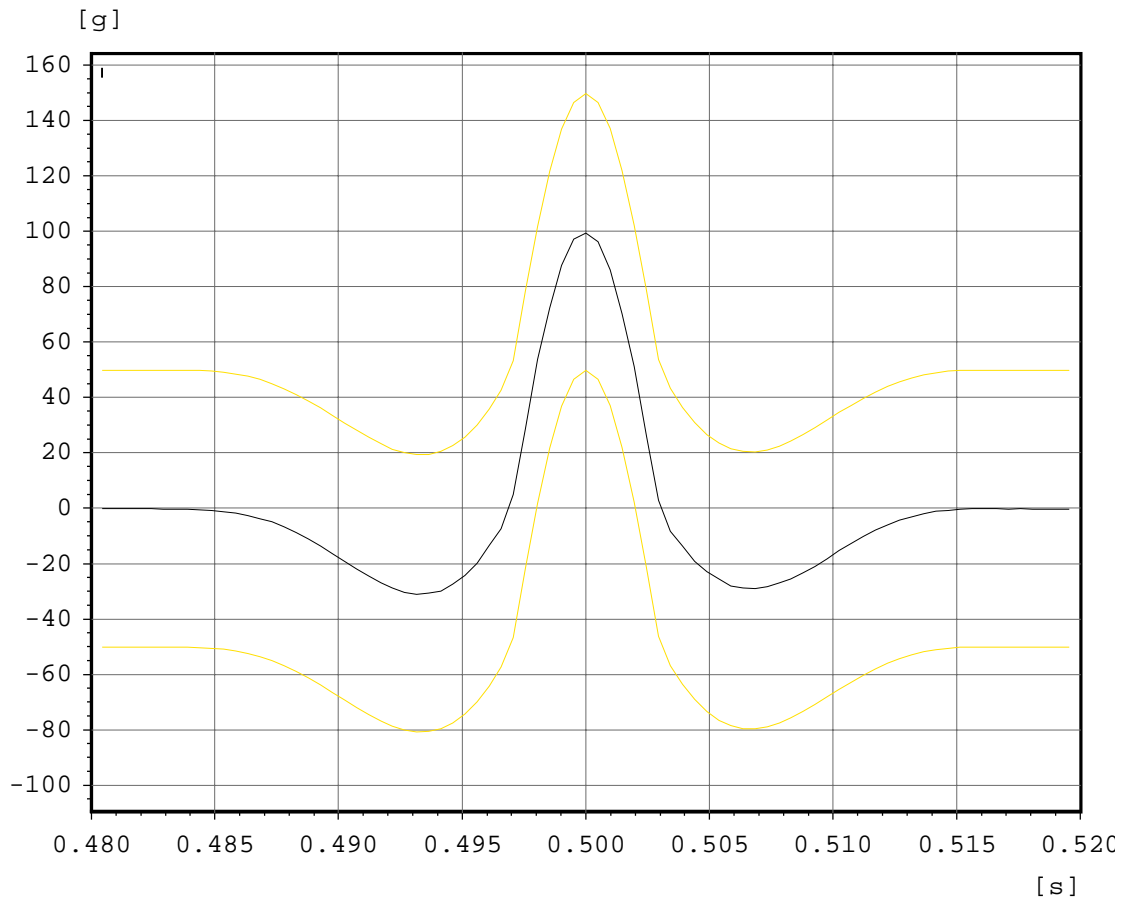
FIGURE #18

Project 208125
Cal Wave 2
Southwest
Microwave
Tech: /MOB
07/21/09

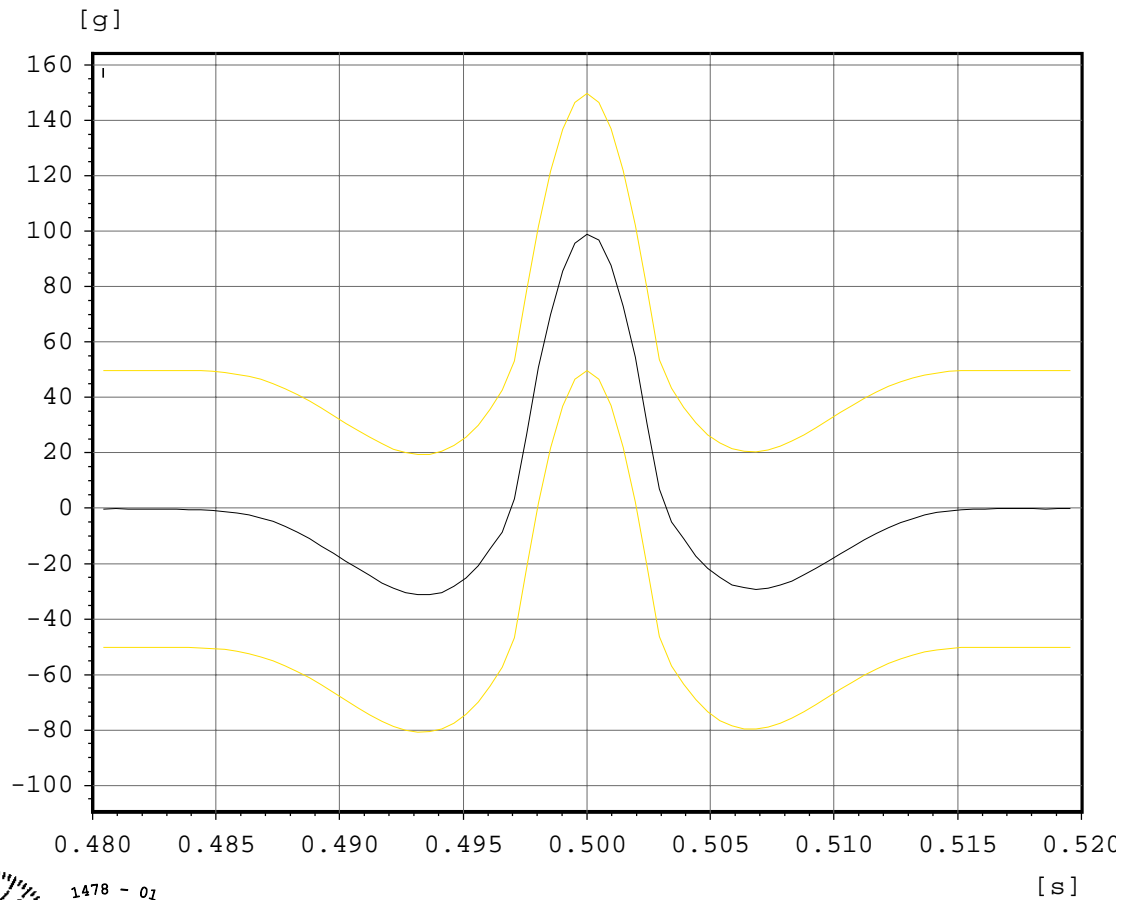
FIGURE #19

Project 208125
Actual wave
Southwest
Microwave
Tech: /MOB
07/27/09
